# INDIAN ISLAND FLEET MOORINGS UNDERWATER INSPECTION REPORT

APRIL 1983

OCEAN ENGINEERING  
AND CONSTRUCTION PROJECT OFFICE  
CHESAPEAKE DIVISION  
NAVAL FACILITIES ENGINEERING COMMAND  
WASHINGTON, D.C. 20374

FPO-1-83 (2)

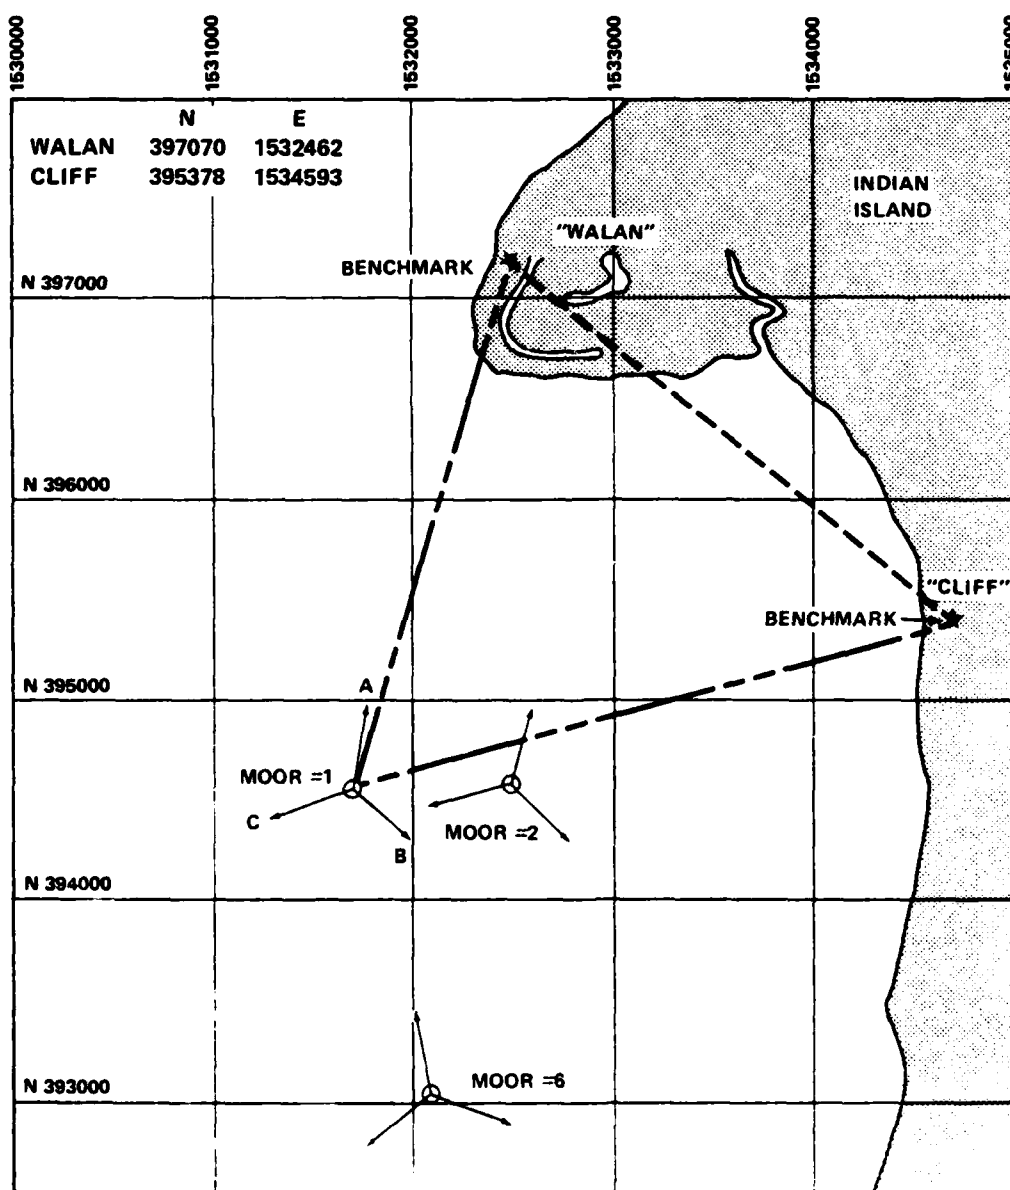
# Survey Data: Indian Island Mooring Inspection

This is a 12' diameter Mark II Peg Top type buoy. Some light to moderate rusting is evident, and the buoy's lower hull is covered with a heavy marine growth. The buoy has two wooden fenders and a chafing rail, all in good condition. The buoy's top and bottom connecting hardware appear to be in good condition. The position of the buoy is currently about 150' west of its installed position.

The mooring chain is in satisfactory condition for continued use in its currently rated and tested capacity as a modified Class E mooring. However, the buoy's current position indicates a significant displacement of the ground legs and anchors. Recommend the forces on the buoy be reevaluated with the possibility of a redesign and repositioning of the mooring back to its original position.

Angle from Walan	Angle from Cliff	N	E	Date
Mooring #1	71° 11'	54° 13'	394519.37	1531400.55	11/8/82
Installed Position			394519.00	1531558.00	2/3/79
Leg A	69° 39'	53° 54'	562.49	511.2	11/8/82
Leg B	71° 15'	54° 13'	518.27	395.75	11/8/82
Leg C	71° 43'	55° 10'	448.27	348.59	11/8/82
